Home Inspection Report

W1111 , Nelson , WI 54756

Monday November 20, 2017

1290

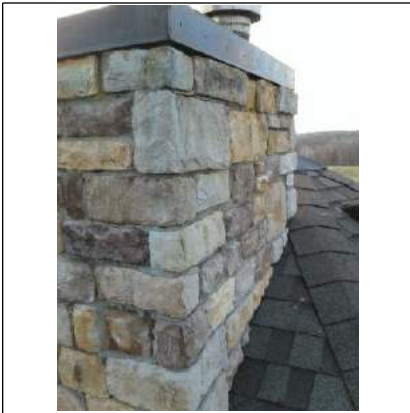
Some maintenance may be needed around the cap a chimney there is some nails that are coming out should be pounded back in.

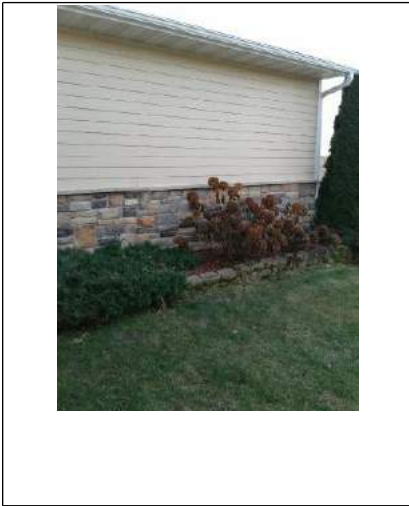
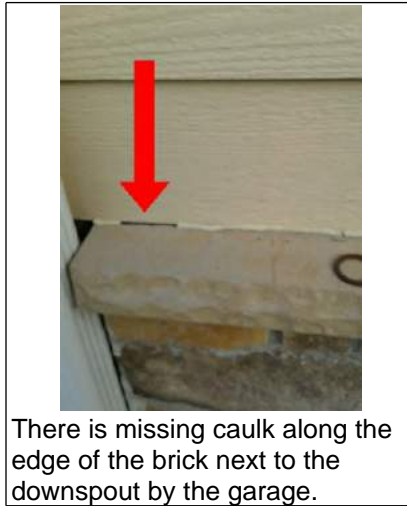
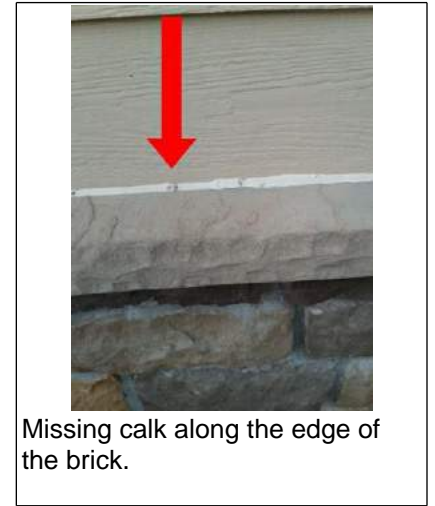
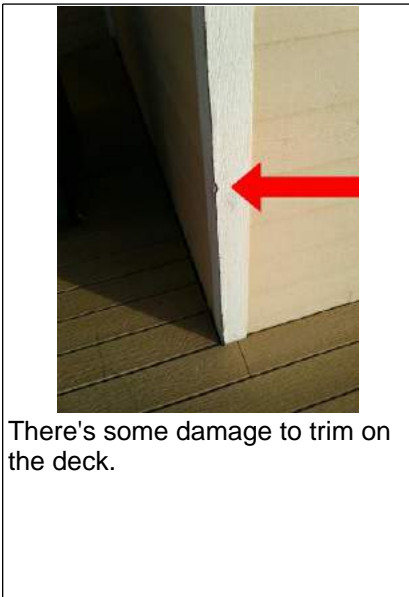
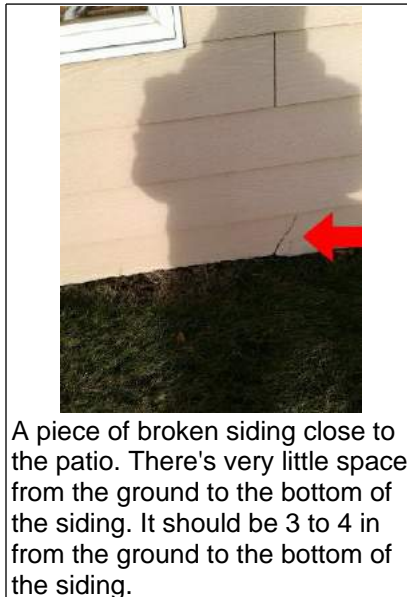
Wall covering There is no flashing between the siding and the brick facade . This creates a maintenance area . Make sure that good quality caulk is maintained between the brick and the wood siding .

Make sure that the caulk is maintained between the siding and the brick exterior. Missing caulk could allow moisture to get in behind the brick and cause damage to the sheathing behind the brick.

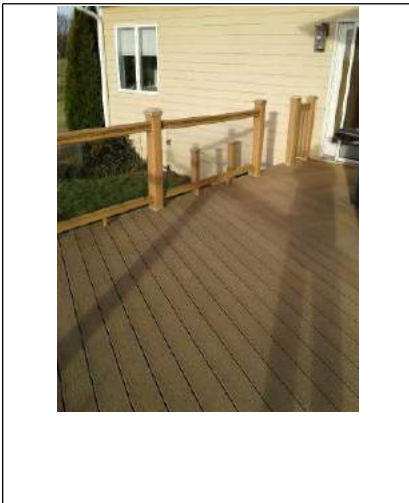
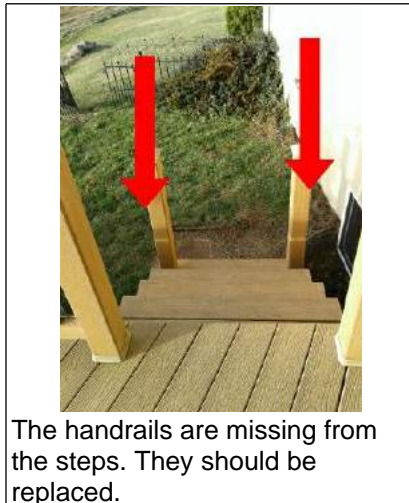
Porch / deck / steps / railings Satisfactory condition. The handrail should be replaced on the steps.

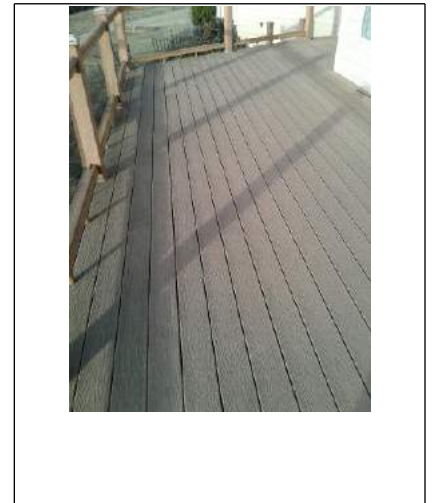
The handrails are missing from the steps. They should be replaced.

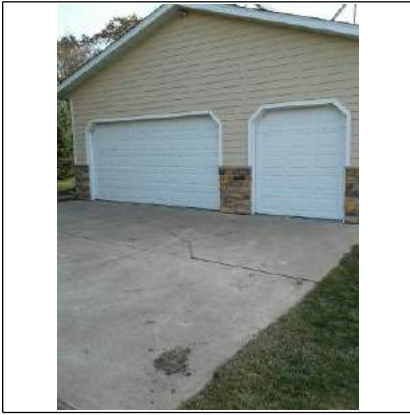
The automatic safety reverse on the large garage door is not working.
The automatic safety reverse the small garage door does not work.

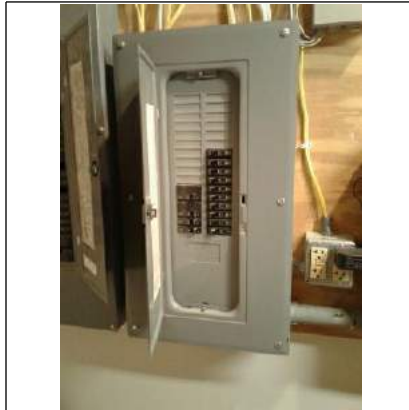
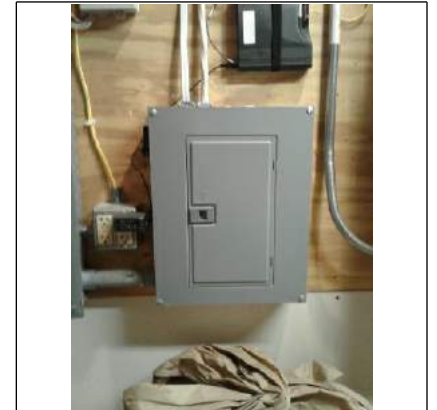
There are several missing Breakers in the Box. The Open Spaces should be filled in with blanks. The taped off Breakers at the top of the box we're for hot tubs which are no longer in the building.

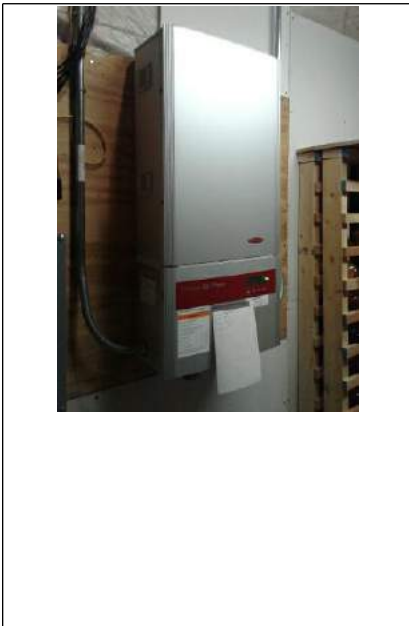
This box was put in for a generator. The generator has never been installed.

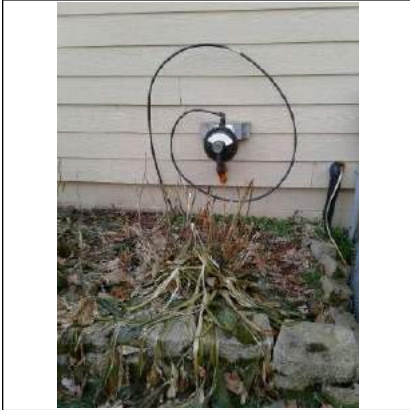
Energy source The copper piping to the house is longer than needed.

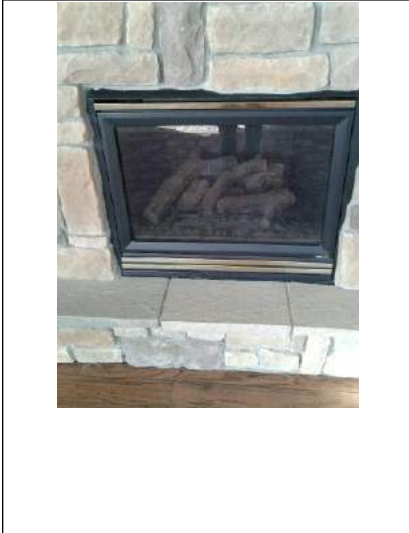
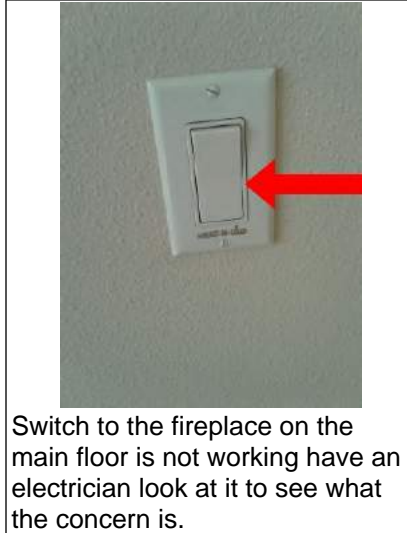
Description Gas fireplace on the main floor. The fireplace Burns correctly and is only controlled with the controls beneath the fireplace itself. The electronic switch to turn on the fireplace it's not working.

Switch to the fireplace on the main floor is not working have an electrician look at it to see what the concern is.
