Home Inspection Report

W1111 , Nelson , WI 54756

Monday November 20, 2017

1290

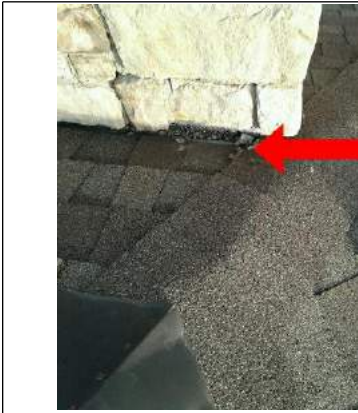
A small piece of brick maybe missing on the corner of the chimney.

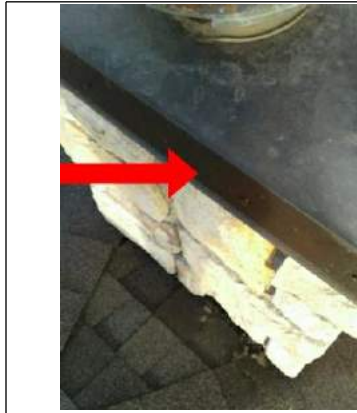
There are a few loose Nails around the chimney cap. They should be pound it in.

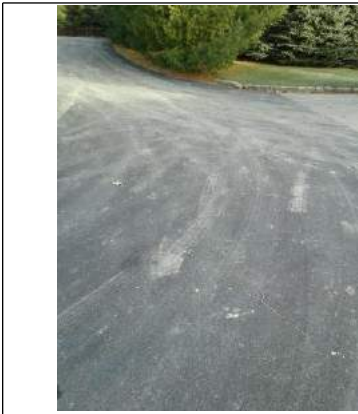
The blacktop driveway is in satisfactory condition.

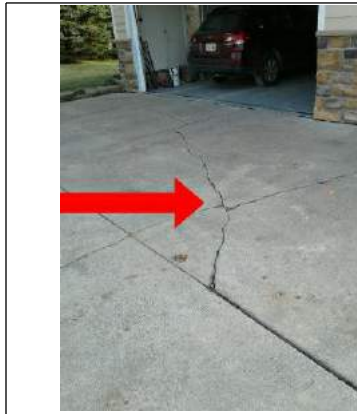
Entry driveways Marginal condition. The pad in front of the garage is cracked in several places.

Several cracks in the cement in front of the garage.
