Home Inspection Report

W1111 , Nelson , WI 54756

Monday November 20, 2017

1290

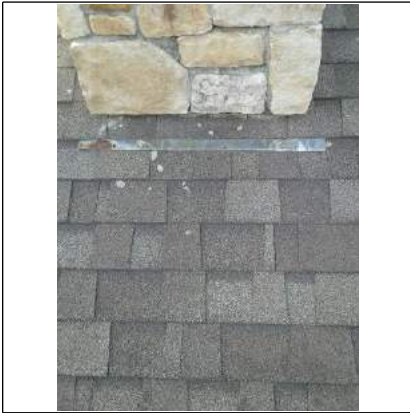
Chimney Monitor: The masonry chimney shows evidence of normal wear and tear. No repairs are necessary.

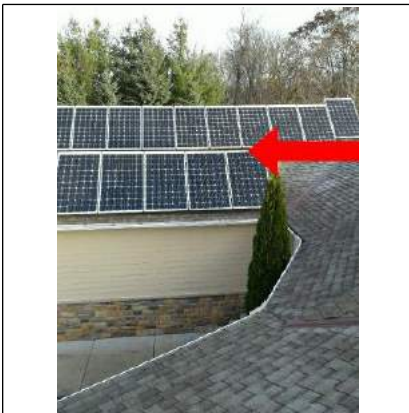
Bank of solar panels.

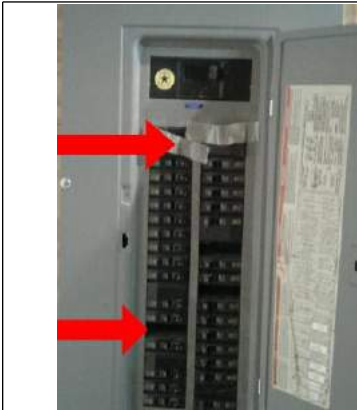
There are several missing Breakers in the Box. The Open Spaces should be filled in with blanks. The taped off Breakers at the top of the box we're for hot tubs which are no longer in the building.

They're missing handrails on the steps off the deck. They should be replaced. Electrician should take a look at the main electrical box in the basement. There are some empty spaces and some incomplete wiring. The empty spaces should be filled in and the two Breakers that are taped should be removed if there is no need for the breakers. The safety of reverse feature on the garage doors are not working. The garage doors could use some maintenance and adjustments.

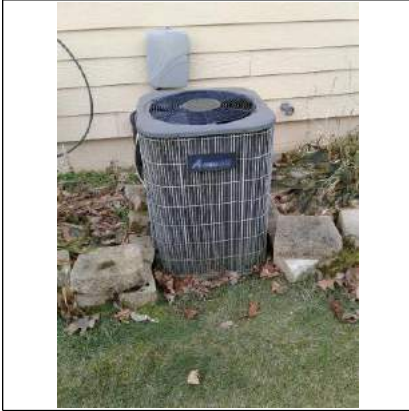
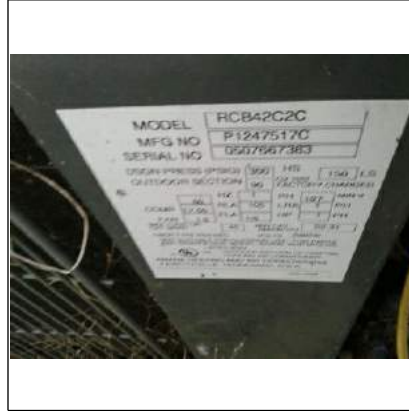
The air conditioning unit was not run because of the cold weather. The air conditioning unit is about 12 years old its original to the home.

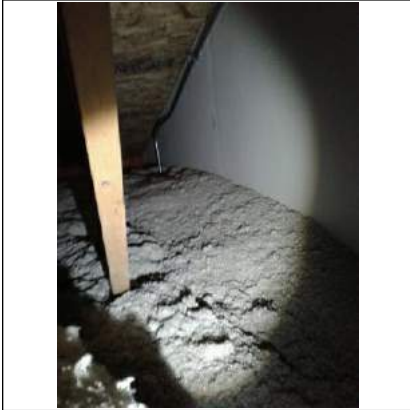
Attic 14 inches of blown in insulation over the entire house. There's about 12 in over the garage. This gives an R-factor for the home of about 38.

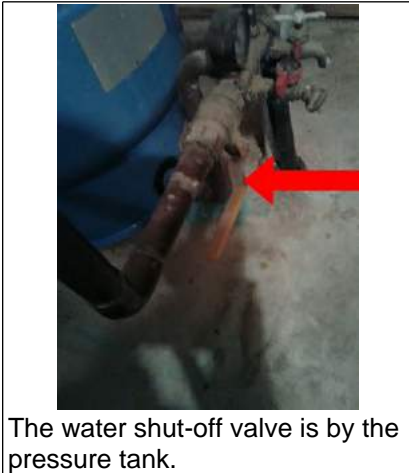
The water shut-off valve is by the pressure tank.

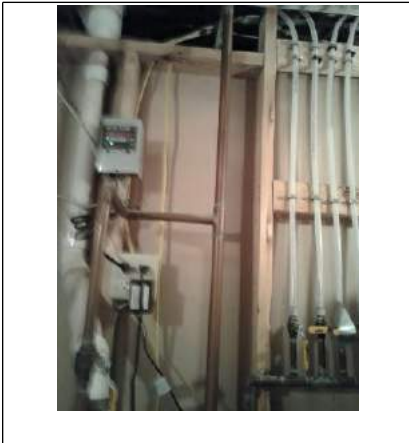
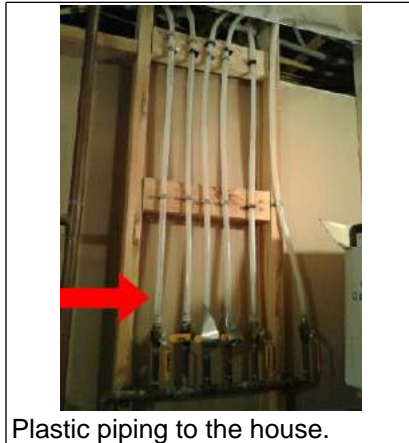
Plastic piping to the house.

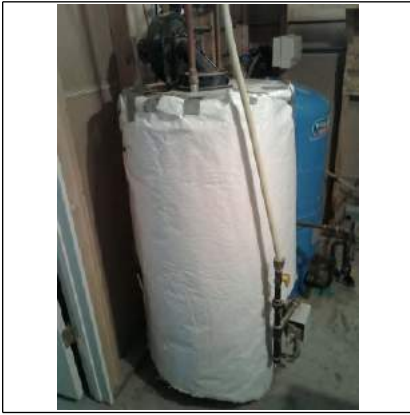
Water heater 52 gallon Bradford White Water Heater . Its original to the home it's about 12 years old .
• Gas

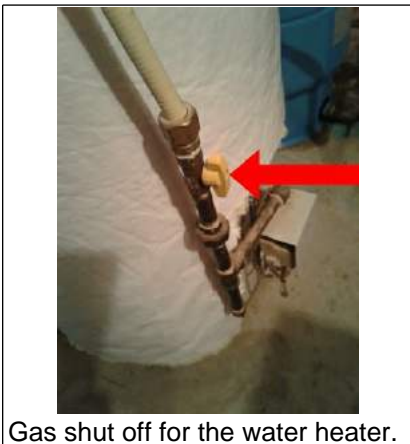
Gas shut off for the water heater.

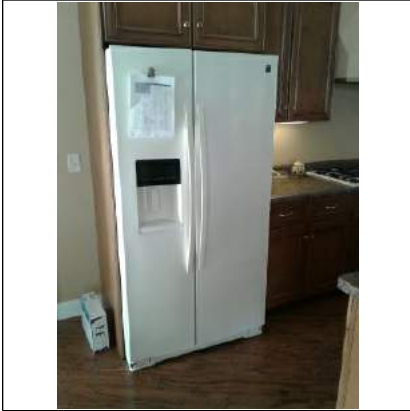
Refrigerator unit Indoor unit purchased in the last 12 months. Satisfactory condition

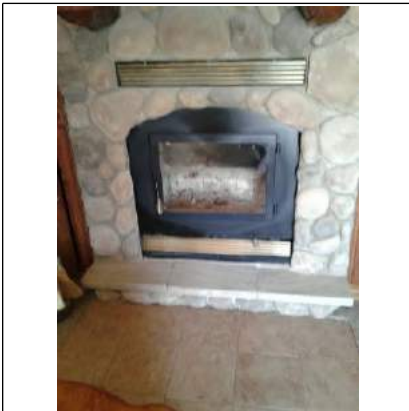
Fireplace Wood fireplace in the family room in the basement. Satisfactory condition
